MILK RIVER RIPARIAN AREA MANAGEMENT OBJECTIVES

Discussion Paper for the Milk River Integrated Watershed Management Plan and State of the Watershed Report 2013

Prepared by: Palliser Environmental Services Ltd.

Prepared for: Milk River Watershed Council Canada

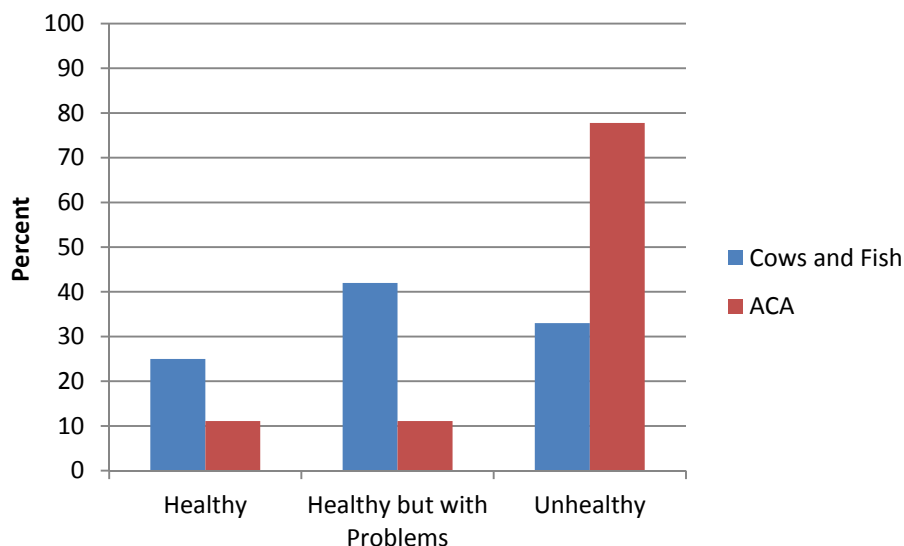
Figure 2. Summary of riparian health categories for wetlands in the Milk River watershed, 2011. Note N=12 for Cows and Fish data (1998-2008), N=9 for ACA data (2011).

Cows and Fish assessed 12 wetlands in the Milk River watershed from 1998 to 2008. Five of the sites were assessed in Reach 4 and 7 sites were assessed in Reach 5. The results showed that 25% of sites were rated as Healthy, 42% of sites were rated as Healthy with Problems and 33% were rated as Unhealthy (Figure 2).

Nine wetlands in the watershed were assessed in 2011 by the Alberta Conservation Association. All of the sites assessed were located in Reach 4. Overall, 11% of sites rated as Healthy, 11% of sites rated Healthy with Problems and 78% of sites rated Unhealthy (Figure 2).

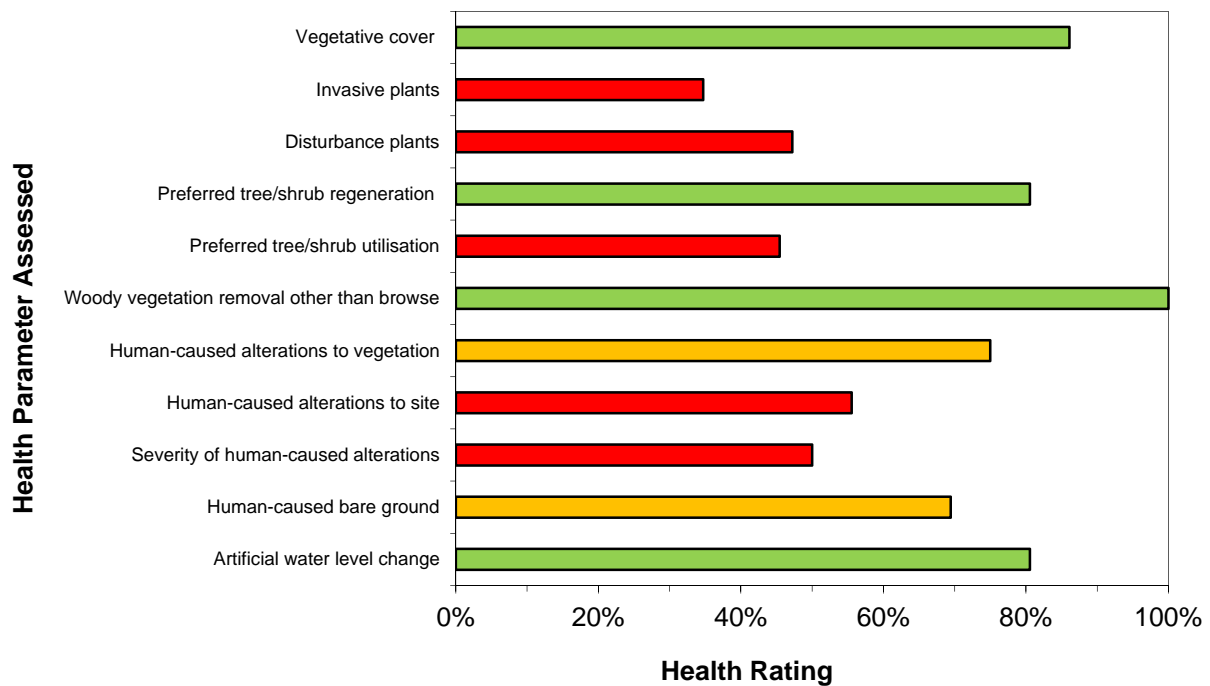
Figure 3. Summary of riparian health indicators for wetlands reported by Cows and Fish, 1998 to 2008 (N=12). Green indicates Healthy, yellow indicates Healthy with Problems and red indicates Unhealthy ratings.

Figure 3 summarizes the results for the various riparian health indicators representing wetlands in the Milk River watershed as reported by Cows and Fish. Indicators that rated Healthy were vegetative cover, preferred tree and shrub regeneration, woody vegetation removal other than browse and artificial water level change. Two indicators related to human influences were rated Healthy with Problems. These were human-caused alterations to vegetation and human-caused bare ground. Although the indicator “vegetative cover” rated Healthy, the indicators invasive and disturbance plants rated Unhealthy. Human-caused alterations to site and the severity of the human-caused alterations also rated Unhealthy.

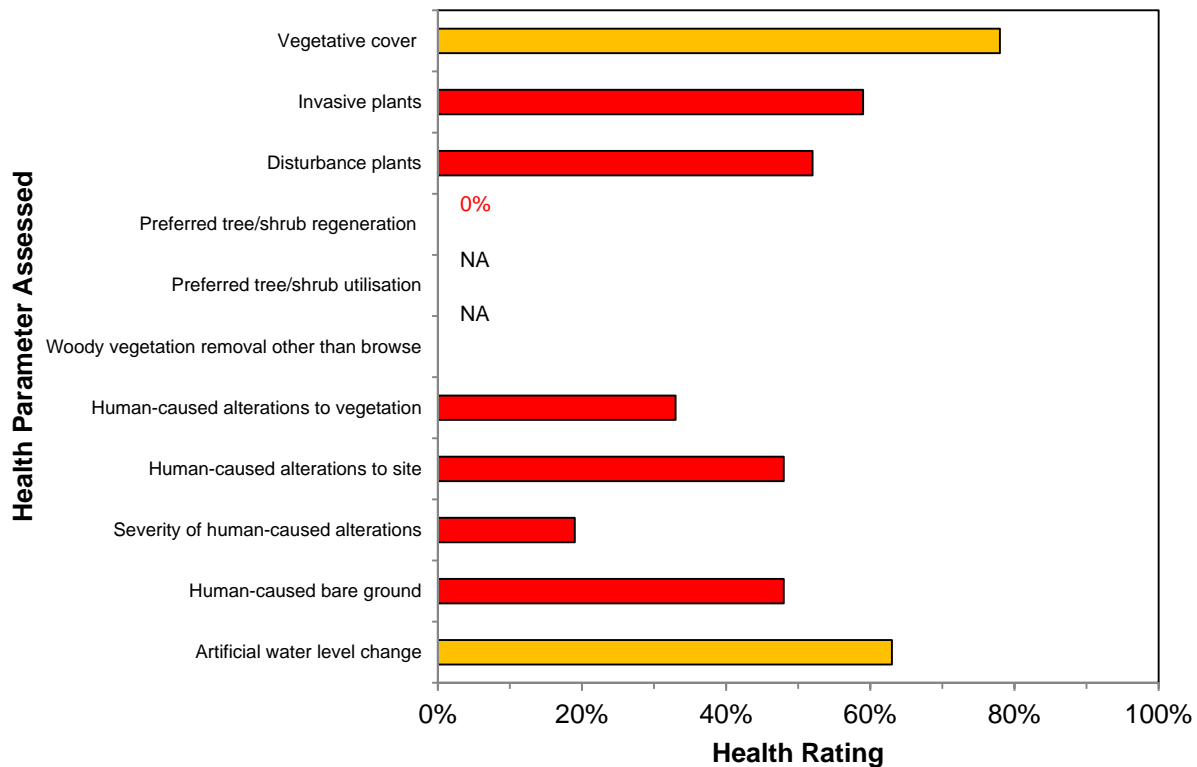
Figure 4. Summary of riparian health indicators for wetlands reported by Alberta Conservation Association, 2011 (N=9). Green indicates Healthy, yellow indicates Healthy with Problems and red indicates Unhealthy ratings. The letters “NA” represent “not applicable”.

Figure 4 summarizes the average score that was assigned to riparian health indicators as collected by the Alberta Conservation Association in 2011. There was no indicator rated Healthy in the 2011 assessment. Indicators that rated Healthy with Problems were vegetative cover and artificial water level change. Similar to the Cows and Fish assessment, indicators that were rated Unhealthy by ACA were invasive and disturbance plants, human-caused alteration to site and severity of human-caused alterations. In addition, human-caused alterations to vegetation and human-caused bare ground rated Unhealthy by ACA, compared to the Healthy with Problems rating assigned to these to indicators in the Cows and Fish assessment.

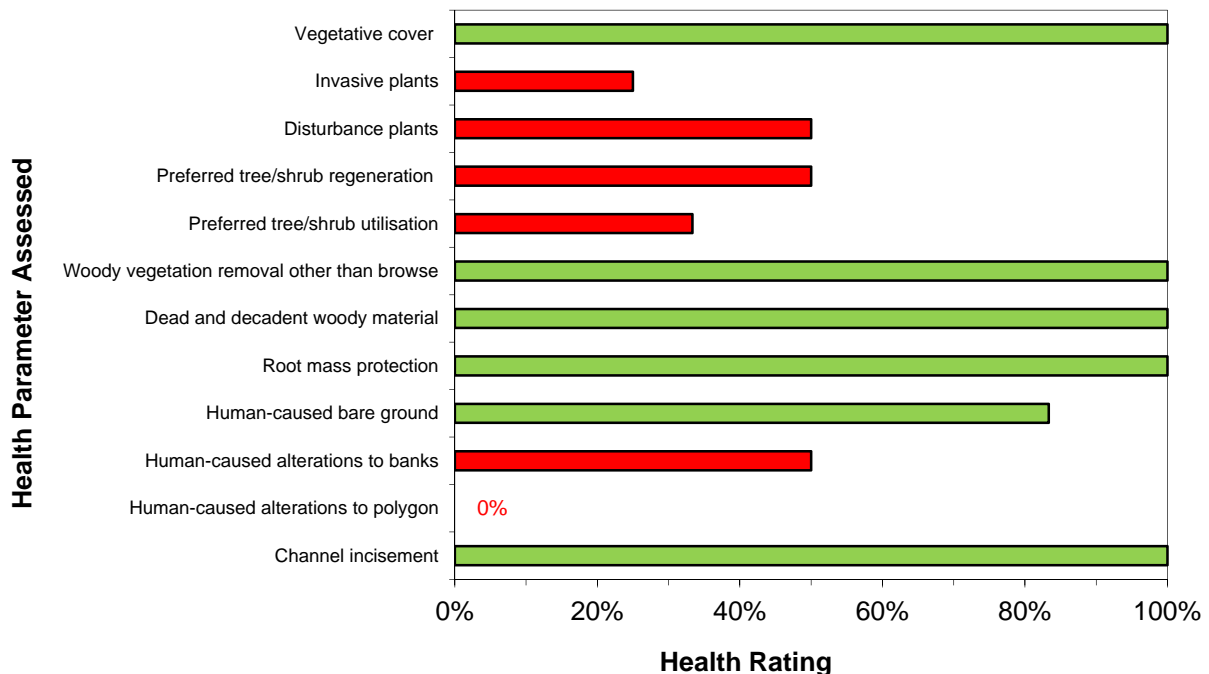
Figure 5. Summary of riparian health indicators at a tributary to the North Fork Milk River, reported by Cows and Fish, 2009 (N=2). Green indicates Healthy, yellow indicates Healthy with Problems and red indicates Unhealthy ratings.

Two riparian sites were assessed in 2009 at one tributary in Reach 1, representing about 1 km of that tributary. Both sites rated in the Healthy with Problems category. Indicators that rated Healthy were vegetative cover, woody vegetation removal other than browse, dead and decadent woody material, root mass protection, human-caused bare ground and channel incisement (Figure 5). Indicators that rated Unhealthy were invasive and disturbance plants, preferred tree/shrub utilization and regeneration, human-caused alteration to banks and human caused alteration to polygon. No indicators rated in the Healthy with Problems category.

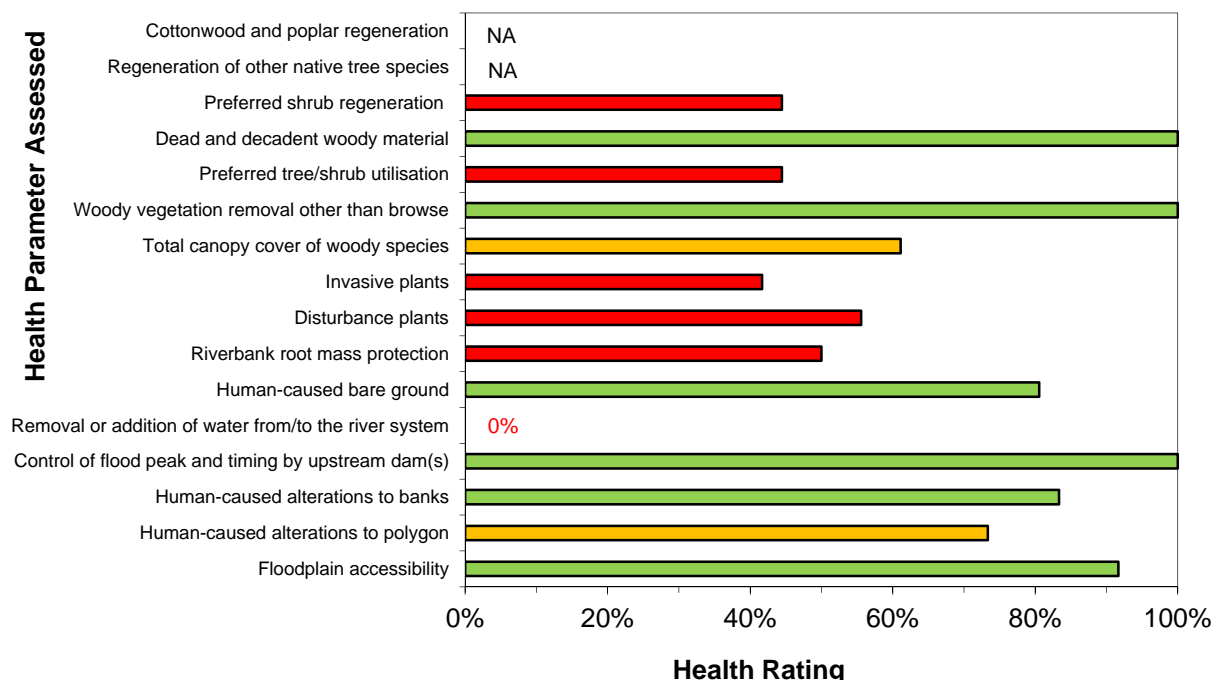
Figure 6. Summary of riparian health indicators at Reach 1 - North Fork Milk River, reported by Cows and Fish, 2000-2009 (N=12). Green indicates Healthy, yellow indicates Healthy with Problems and red indicates Unhealthy ratings. The letters “NA” represent “not applicable”.

Twelve riparian sites were assessed from 2000 to 2009 at Reach 1 – North Fork Milk River, representing about 11.5 km. No site was rated Healthy, 83% of sites rated in the Healthy with Problems category and 17% of sites rated Unhealthy. Indicators that rated Healthy were dead and decadent woody material, woody vegetation removal other than browse, human-caused bare ground, control of flood peak and timing by upstream dam(s), human-caused alterations to banks and floodplain accessibility (Figure 6). Indicators that rated in the Healthy with Problems category were total canopy cover of woody species and human-caused alterations to the

polygon. Indicators that rated Unhealthy were preferred shrub regeneration, preferred tree/shrub utilization, invasive and disturbance plants, riverbank root mass protection and removal or addition of water from/to the river system.

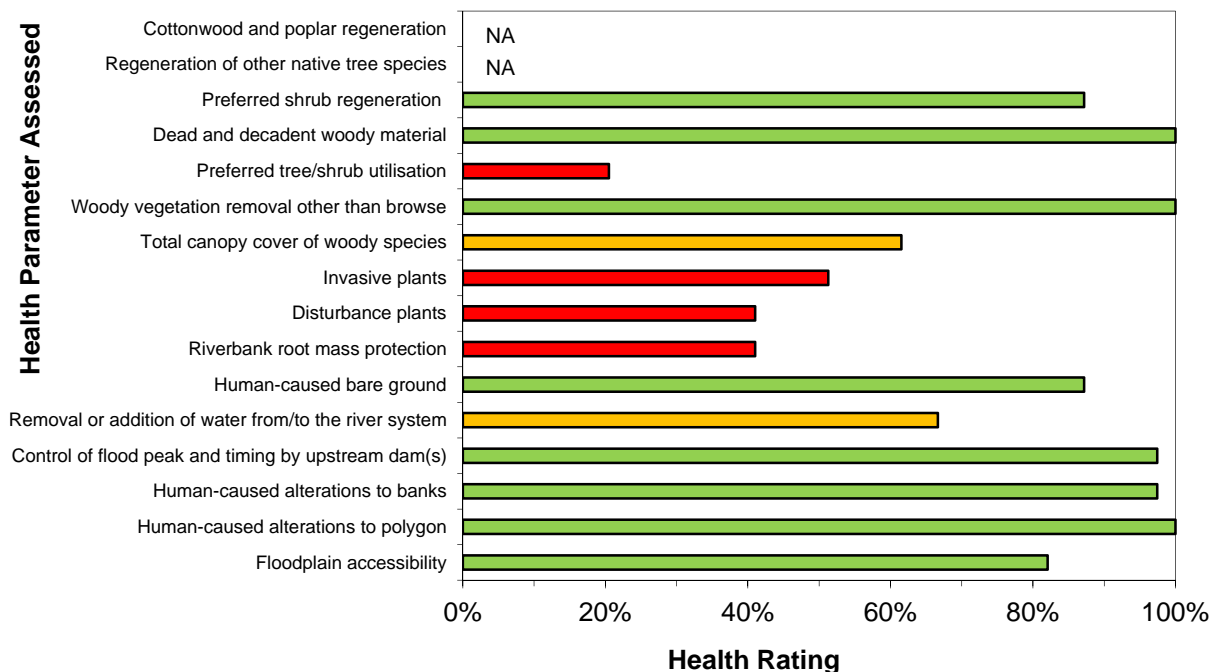
Figure 7. Summary of riparian health indicators at Reach 2 – South Fork Milk River, reported by Cows and Fish, 2000 and 2009 (N=13). Green indicates Healthy, yellow indicates Healthy with Problems and red indicates Unhealthy ratings. The letters “NA” represent “not applicable”.

Thirteen riparian sites were assessed at Reach 2 – South Fork Milk River, six in 2000 and seven in 2009. Fifty-four percent of sites rated in the Healthy category, 23% of sites rated Healthy with Problems and 23% of sites rated Unhealthy. Indicators that rated Healthy were preferred shrub regeneration, dead and decadent woody material, woody vegetation removal other than browse, human-caused bare ground, control of flood peak and timing by upstream dam(s), human-caused alterations to banks, human-caused alterations to polygon and floodplain accessibility (Figure 7). Indicators that rated Healthy with Problems were total canopy cover of woody species and removal or addition of water from/to the river system. Indicators that rated Unhealthy were preferred tree/shrub utilization, invasive and disturbance plants and riverbank root mass protection.

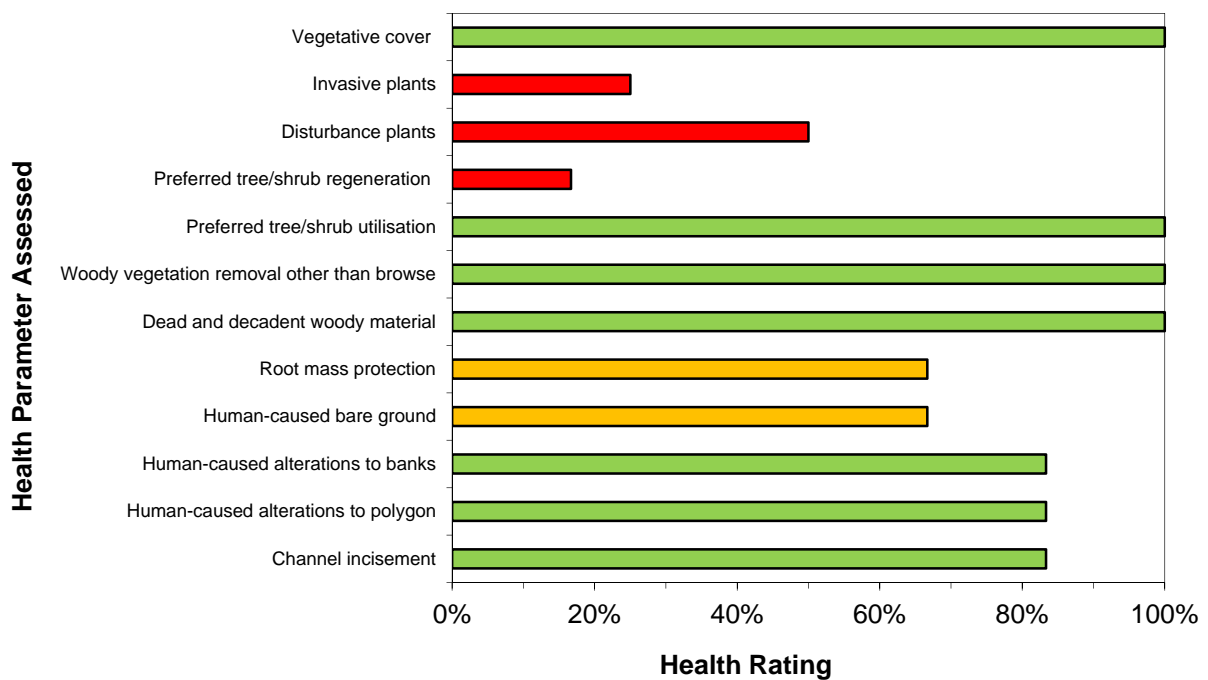
Figure 8. Summary of riparian health indicators at one tributary to Reach 3 – Milk River Gravel-bed Reach, reported by Cows and Fish, 2008 (N=2). Green indicates Healthy, yellow indicates Healthy with Problems and red indicates Unhealthy ratings.

In 2008, two riparian health assessments were conducted on one tributary at Reach 3 by Cows and Fish. Both sites rated in the Healthy with Problems category. Indicators that rated Healthy were vegetative cover, preferred tree/shrub utilization, woody vegetation removal other than browse, dead and decadent woody material, human-caused alterations to banks, human-caused alterations to polygon and channel incisement (Figure 8). Indicators that rated Healthy with Problems were root mass protection and human-caused bare ground. Indicators that rated Unhealthy were invasive and disturbance plants and preferred tree/shrub regeneration.

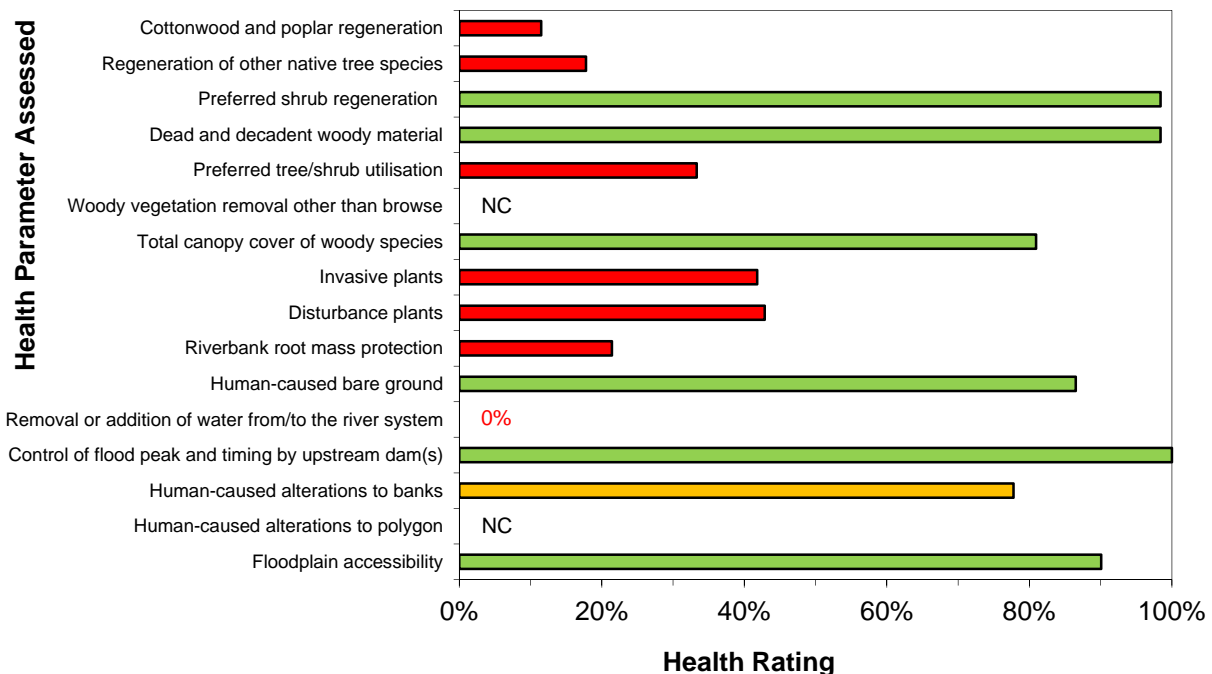
Figure 9. Summary of riparian health indicators at Reach 3 – Milk River Gravel-bed Reach, reported by Cows and Fish, 1999 and 2000 (N=42). Green indicates Healthy, yellow indicates Healthy with Problems and red indicates Unhealthy ratings. The letters “NC” represent “not collected”.

Forty-two riparian sites were assessed at Reach 3 – Milk River Gravel-bed Reach, in 1999 and 2000. Two percent of sites rated in the Healthy category, 41% of sites rated Healthy with Problems and 57% of sites rated Unhealthy. Indicators that rated health were preferred shrub regeneration, dead and decadent woody material, total canopy cover of woody species, human-caused bare ground, control of flood peak and timing by upstream dam(s) and floodplain accessibility (Figure 9). The indicator that rated Healthy with Problems was human-caused alteration to banks. Indicators that rated Unhealthy were cottonwood and poplar regeneration, regeneration of other native tree species, preferred tree/shrub utilization, invasive and disturbance plants and riverbank root mass protection.

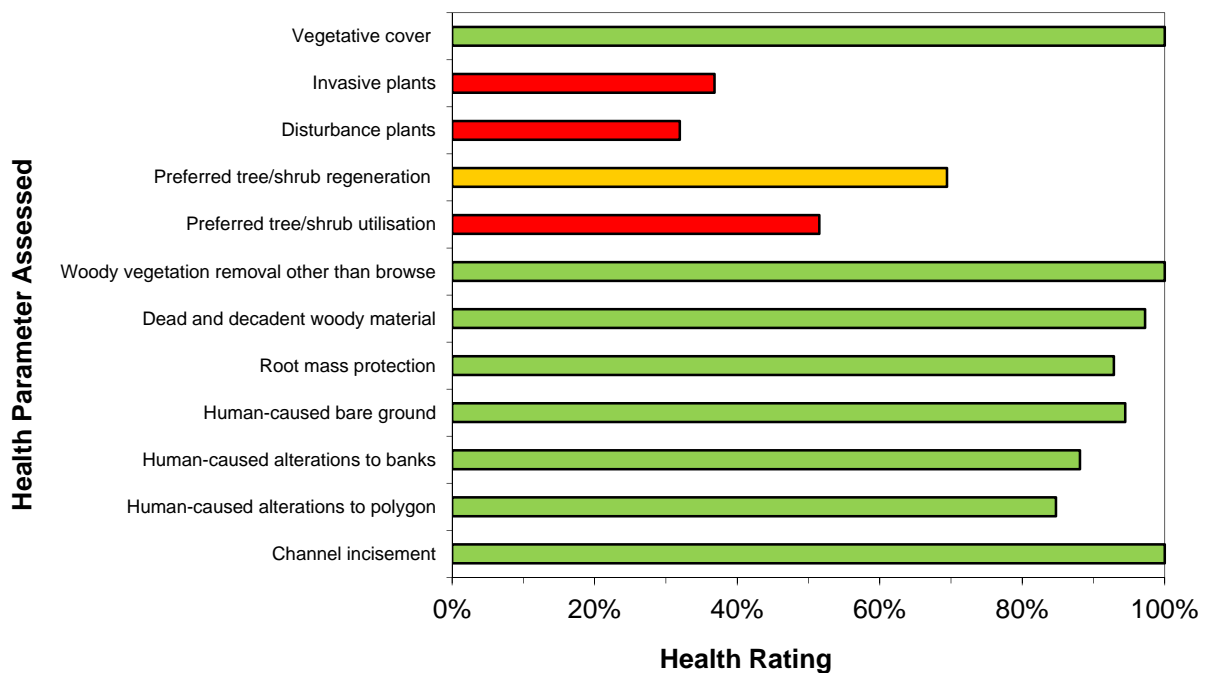
Figure 10. Summary of riparian health indicators for tributaries in Reach 4 – Milk River Sand-bed Reach, reported by Cows and Fish, 1997-2011 (N=24). Green indicates Healthy, yellow indicates Healthy with Problems and red indicates Unhealthy ratings.

Twenty-four riparian health assessments were conducted on tributaries at Reach 4 by Cows and Fish. Forty-six percent (46%) of sites rated Healthy and 54% of sites rated in the Healthy but with problem category. Indicators that rated Healthy were vegetative cover, woody vegetation removal other than browse, dead and decadent woody material, root mass protection, human-caused bare ground, human-caused alterations to banks, human-caused alterations to polygon and channel incisement (Figure 10). The indicators that rated Healthy with Problems was preferred trees/shrub regeneration. Indicators that rated Unhealthy were invasive and disturbance plants and preferred tree/shrub utilization.

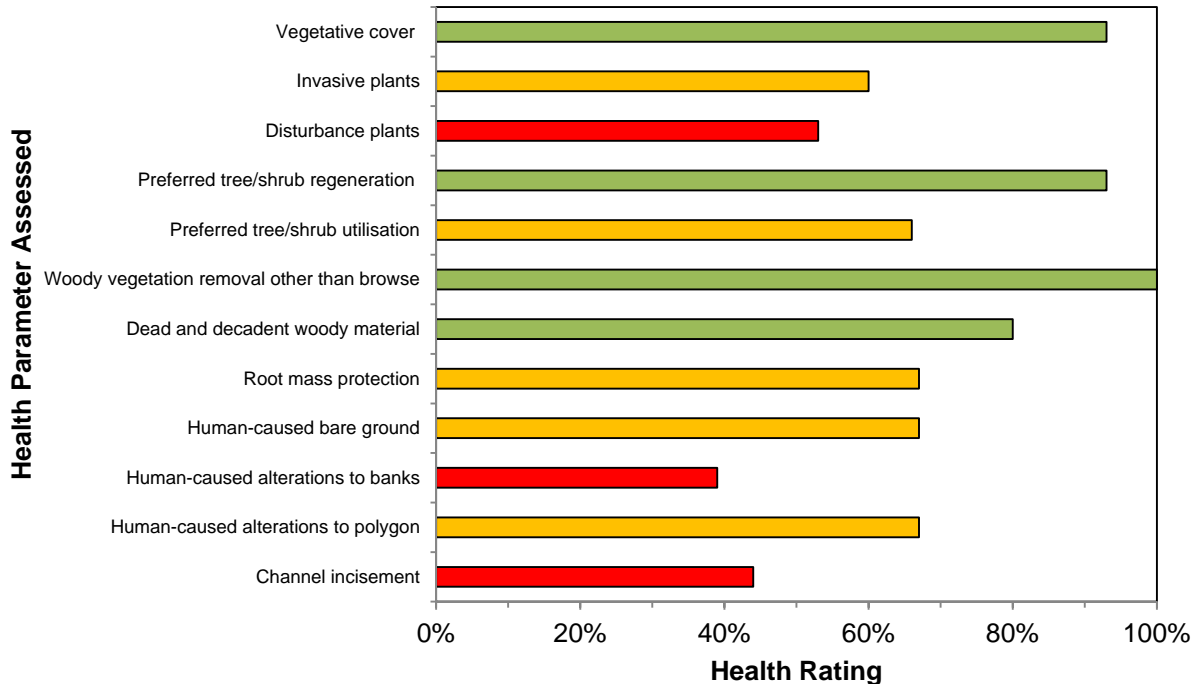
Figure 11. Summary of riparian health indicators for tributaries in Reach 4 – Milk River Sand-bed Reach, reported by Alberta Conservation Association, 2011 (N=5). Green indicates Healthy, yellow indicates Healthy with Problems and red indicates Unhealthy ratings.

In 2011, ACA assessed five sites at tributaries in Reach 4 (different from those assessed by Cows and Fish). Twenty percent (20%) of riparian sites assessed rated in the Healthy category, 60% of the sites rated Healthy with Problems and 20% of sites rated Unhealthy. Similar to the Cows and Fish data set, indicators that rated Healthy were vegetative cover, woody vegetation removal other than browse and dead and decadent woody material (Figure 11). In addition, preferred tree/shrub regeneration rated Healthy. Root mass protection, human-caused bare ground, human-caused alterations to polygon and channel incisement rated Healthy in the Cows and Fish data base, but ACA rated these parameters Healthy with Problems, as well as invasive plants. The indicators that rated Healthy with Problems by ACA were disturbance plants, human-caused alterations to banks and channel incisement.

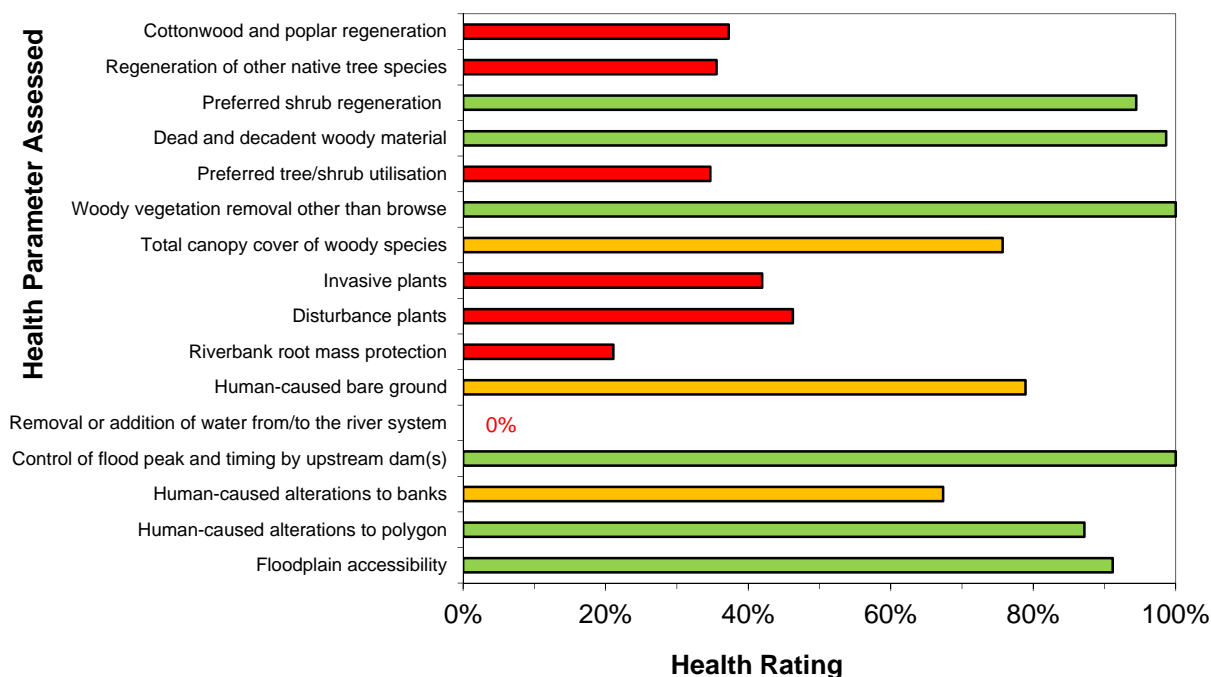
Figure 12. Summary of riparian health indicators (Large River form) at Reach 4 – Milk River Sand-bed Reach, reported by Cows and Fish, 1999 to 2011 (N=49). Green indicates Healthy, yellow indicates Healthy with Problems and red indicates Unhealthy ratings.

For sites that were assessed using the form for Large Rivers, indicators that rated Healthy were preferred shrub regeneration, dead and decadent woody material, woody vegetation removal other than browse, control of flood peak and timing by upstream dam(s), human-caused alteration to polygon and floodplain accessibility (Figure 12). The indicators that rated Healthy with Problems were total canopy cover of woody species, human-caused bare ground and human-caused alterations to banks. Indicators that rated Unhealthy were cottonwood and poplar regeneration, regeneration of other native tree species, preferred tree/shrub utilization, invasive and disturbance plants, riverbank root mass protection and removal or addition of water from/to the river system.

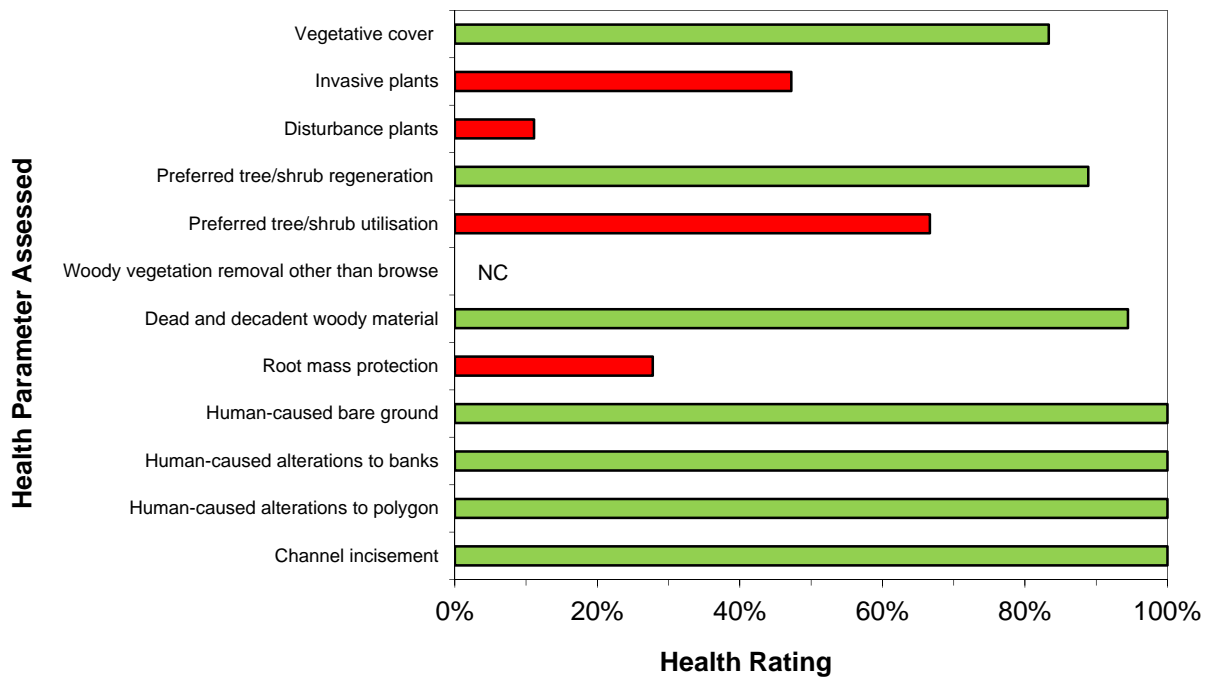
Figure 13. Summary of riparian health indicators (Streams and Small Rivers form) at Reach 4 – Milk River Sand-bed Reach, reported by Cows and Fish, 1997, 2007 (N=6). Green indicates Healthy, yellow indicates Healthy with Problems and red indicates Unhealthy ratings.

For sites that were assessed using the form for Streams and Small Rivers, indicators that rated in the Healthy category were vegetative cover, preferred tree/shrub regeneration, dead and decadent woody material, human-caused bare ground, human-caused alterations to banks, human-caused alterations to polygon and channel incisement (Figure 13). No indicators rated Healthy with Problems. Indicators that rate Unhealthy were invasive and disturbance plants, preferred tree/shrub utilization and root mass protection.

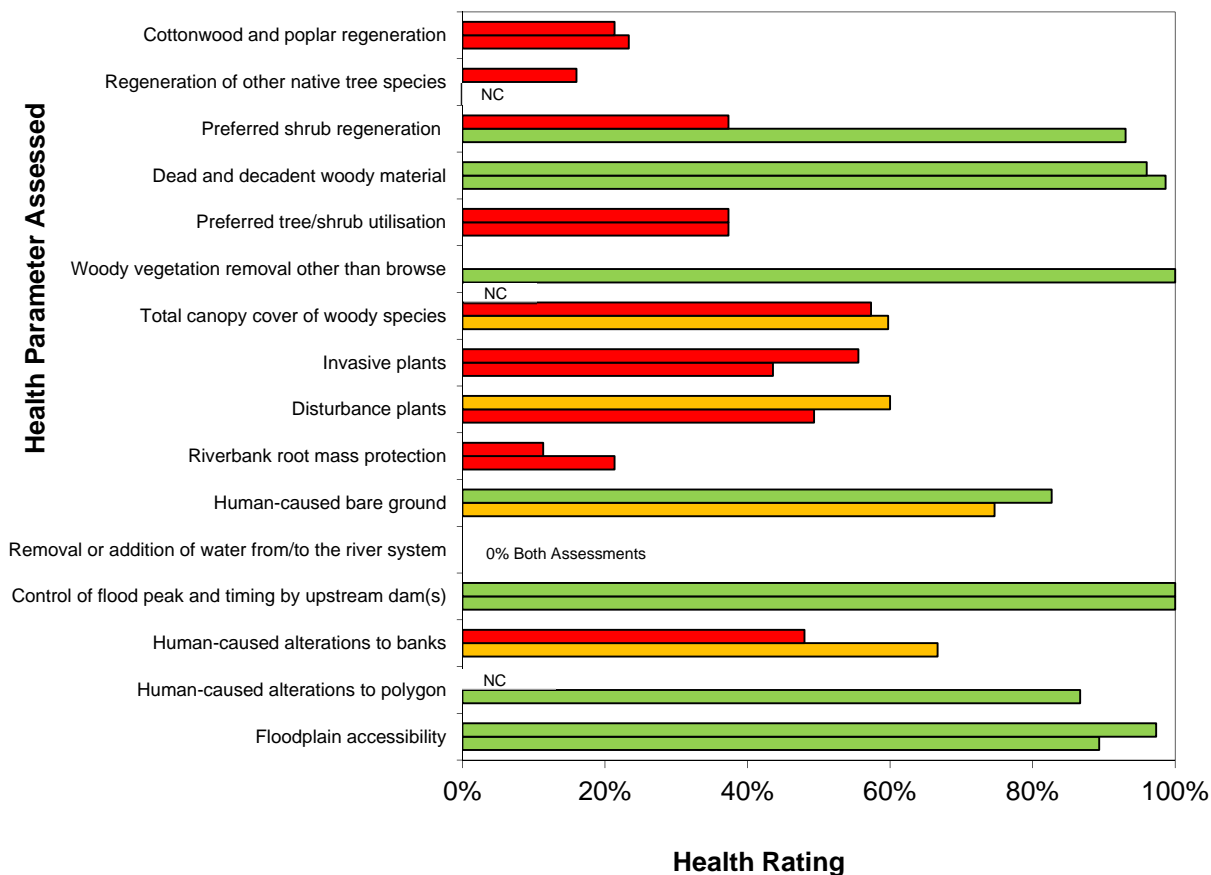
Figure 14. Comparison of riparian health indicators (Large River form) at Reach 4 – Milk River Sand-bed Reach, reported by Cows and Fish, 1998/1999 (top bar) and 2008/2011 re-visits (bottom bar) (N=25). Green indicates Healthy, yellow indicates Healthy with Problems and red indicates Unhealthy ratings.

At Reach 4, 25 sites that were assessed in 1998 and 1999 were re-assessed in 2008 and 2011. For the first assessments (1998 and 1999), the average score was 56, rating riparian areas in this reach Unhealthy. In the re-assessment, the average score was slightly improved (62) rating riparian areas at the lower end of the Healthy with Problems category. Similar to Reach 3 findings, there was great improvement in the indicator tree and shrub regeneration that improved from an Unhealthy rating in the first assessment to a Healthy rating in the re-assessment (Figure 14). The scores for indicators “total canopy cover of woody species” and “human-caused alterations to banks” also improved in the re-assessment. Scores were lower in the re-assessment for indicators associated with invasive and disturbance plants (Figure 15).

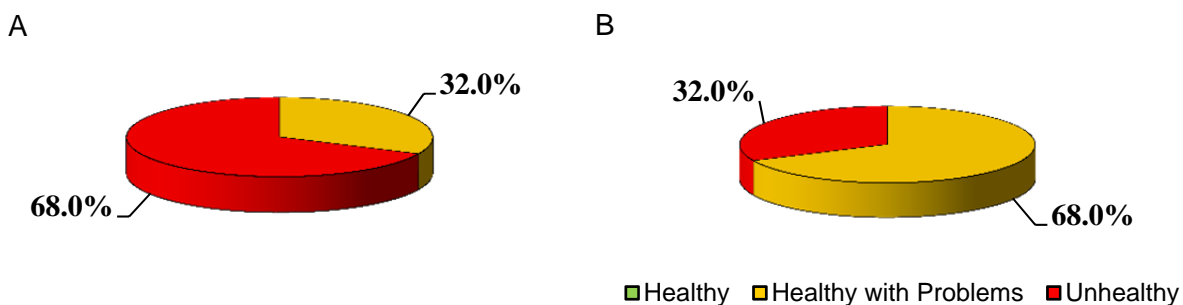
Figure 15. Average health assessment ratings for Reach 4 for the A) 1998/1999 assessments and B) 2008/2011 re-assessments.

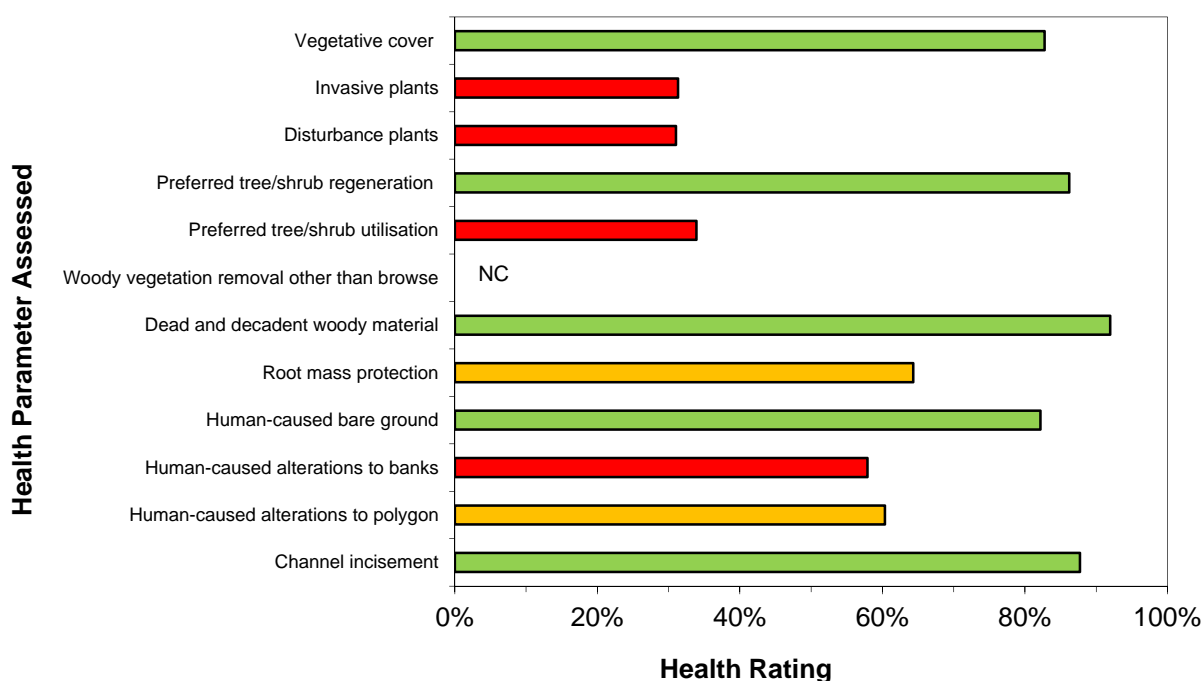
Figure 16. Summary of riparian health indicators for tributaries in Reach 5 – Eastern Tributaries, reported by Cows and Fish, 2000-2003 (N=58). Green indicates Healthy, yellow indicates Healthy with Problems and red indicates Unhealthy ratings.

Indicators that rated Healthy were vegetative cover, preferred shrub regeneration, dead and decadent woody material, human-caused bare ground and channel incisement (Figure 16). The indicators that rated Healthy with Problems were root mass protection and human-caused alterations to polygon. Indicators that rated Unhealthy were invasive and disturbance plants, preferred tree/shrub utilization and human-caused alterations to banks.

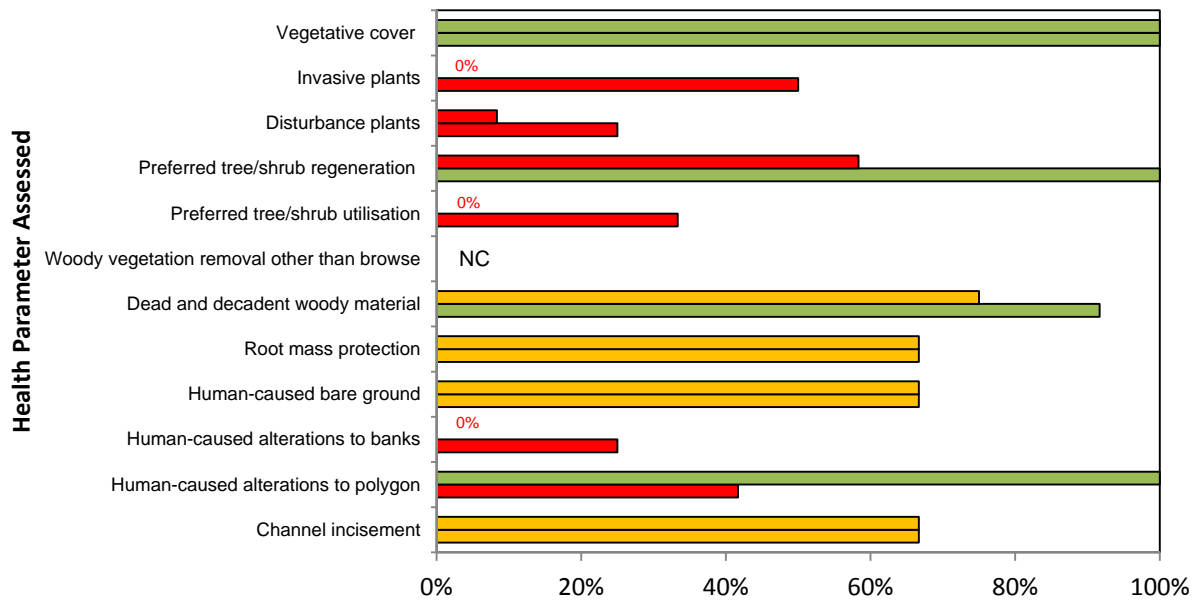
Figure 17. Comparison of riparian health indicators (Streams and Small Rivers form) at Reach 5 – Eastern Tributaries, reported by Cows and Fish, 2001 (top bar) and 2003 re-visits (bottom bar) (N=4). Green indicates Healthy, yellow indicates Healthy with Problems and red indicates Unhealthy ratings.

At Reach 5, 4 tributary sites that were assessed in 2001 were re-assessed in 2003. For the first assessments (2001), the average score was 50.8, rating riparian areas in this reach Unhealthy. In the re-assessment, the average score was slightly improved (63.8) rating riparian areas in the lower end of the Healthy with Problems category. Similar to Reach 3 and 4 findings, there was great improvement in the indicator tree and shrub regeneration that improved from an Unhealthy rating in the first assessment to a Healthy rating in the re-assessment (Figure 17). The scores were also higher in the re-assessment for indicators associated with invasive and disturbance plants (Figure 17).

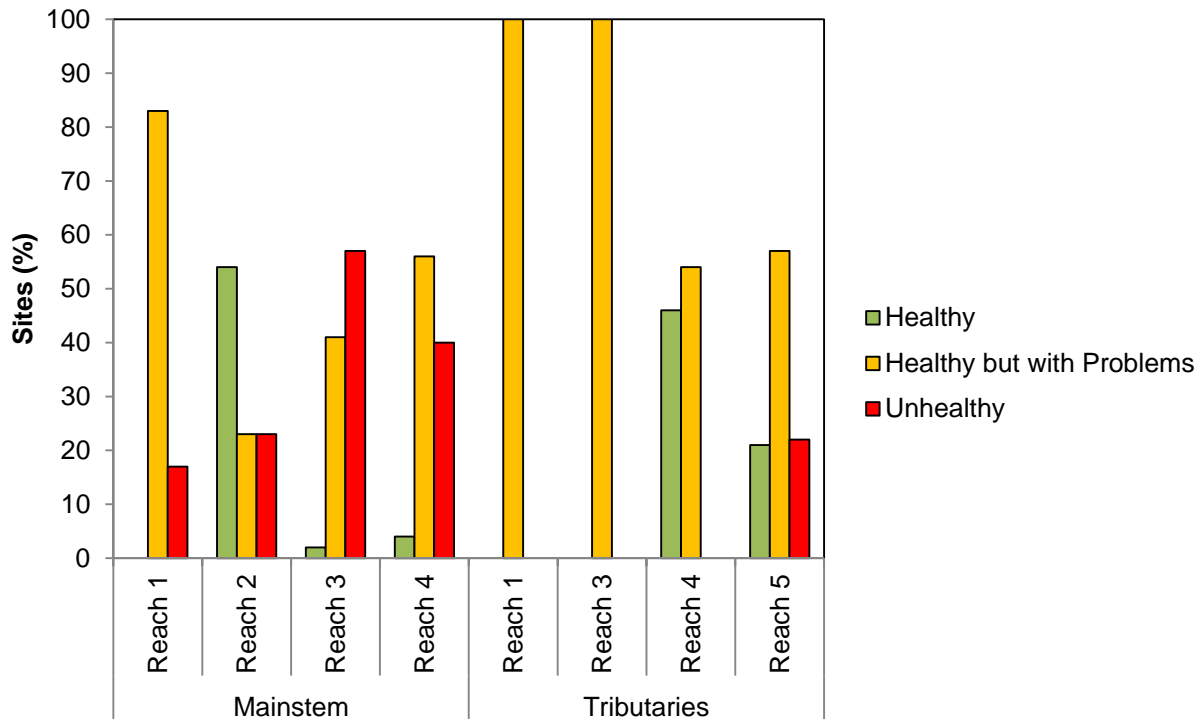
Figure 18. Comparison of average riparian health ratings by Milk River reach and site type.

Figure 18 summarizes the riparian health assessment and inventory data by health category for tributary sites and mainstem sites. For tributaries at Reach 1 – North Fork Milk River and Reach 3 – Milk River Gravel-bed Reach, all sites rated in the Healthy with Problems categories. At Reach 4 – Milk River Sand-bed Reach, about half the tributary sites rated in the Healthy category and half rated in the Healthy with Problems category. At Reach 5 – Eastern Tributaries, the site ratings were distributed among all categories, 21% in the Healthy category, 57% in the Healthy with Problems category and 22% of sites in the Unhealthy category.

For riparian health assessments completed at mainstem Milk River sites, no site rated Healthy at Reach 1 – North Fork Milk River, and 83% of sites rated in the Healthy with Problems category. Reach 2 - South Fork Milk River had the highest percentage of sites that rated in the Healthy category 54% of sites) (Figure 15). Reach 3 – Milk River Gravel-bed Reach had the highest percentage of sites that rated Unhealthy (57% of sites), followed closely by Reach 4 – Milk River Sand-bed Reach (40% of sites).

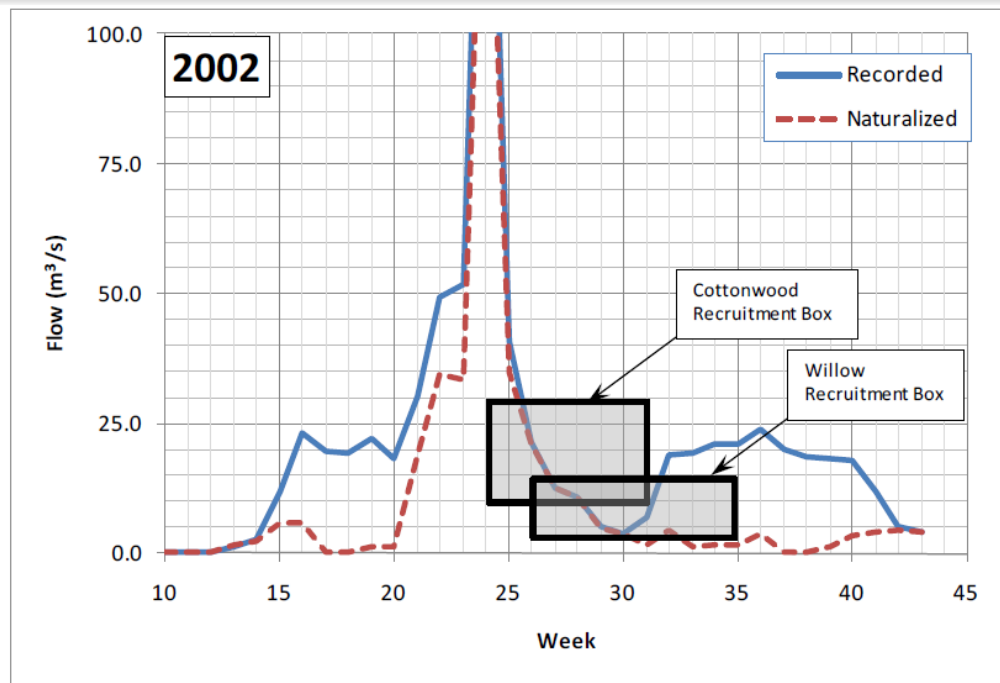
Figure 40: Naturalized and recorded flows for the Milk River at the Eastern Crossing in 2002 with riparian recruitment boxes

Current flow management generates a flow regime with very little within-year seasonal variability. Based on the recruitment box model, the river stage that would provide improved riparian recruitment after a major flow event (i.e., the 1 in 5 year flood event or greater) corresponds to flows between 30 m³/s and 3.5 m³/s. Managing flow recession and providing seasonal flow variability within this range of flows will likely result in improved riparian conditions on the Milk River (Golder Associates 2010).

- c) The timing and duration of flows should be managed to promote the regeneration of preferred native tree species, including cottonwoods and poplars. Based on the recruitment box model, the river stage that would provide improved riparian recruitment after a major flow event (i.e., the 1 in 5 year flood event or greater) corresponds to flows between 30 m³/s and 3.5 m³/s. Managing flow recession and providing seasonal flow variability within this range of flows will likely result in improved riparian conditions on the Milk River (Golder Associates 2010) (Appendix G).

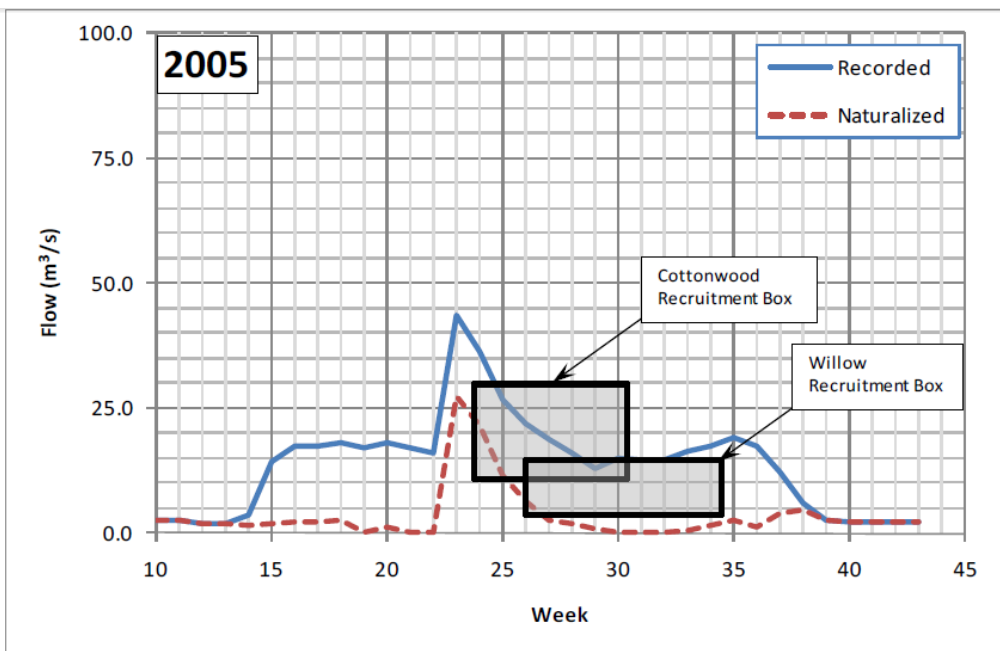
Figure 41: Naturalized and recorded flows for the Milk River at the Eastern Crossing in 2005 with riparian recruitment boxes
